# **Antimisting Fuel (AMK) Flight Degrader Development and Aircraft Fuel System Investigation**

George A. Coffinberry  
Thomas M. Tucker

General Electric Company  
Aircraft Engine Business Group  
Cincinnati, Ohio 45215

Final Report

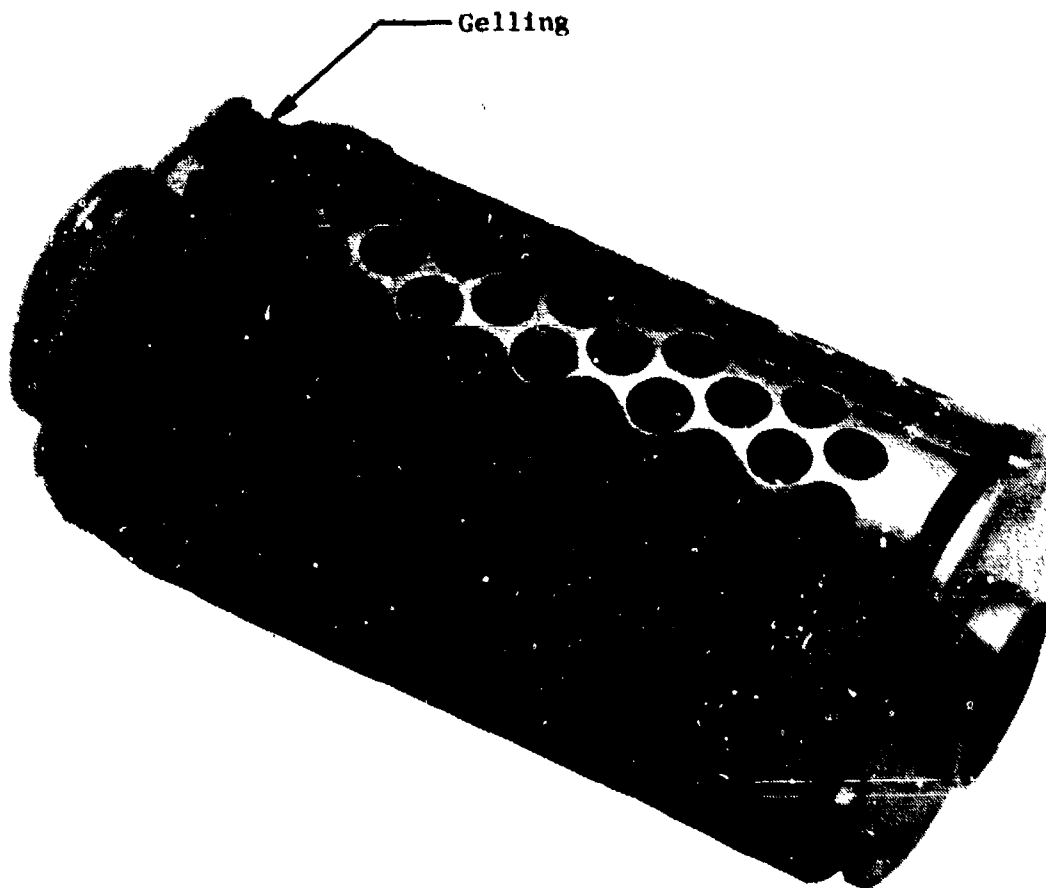
- Flow Passes Through Filter from Outside to Inside

FIGURE 50. FUEL BYPASS FILTER SHOWING EVIDENCE OF AMK PRECIPITATE GEL

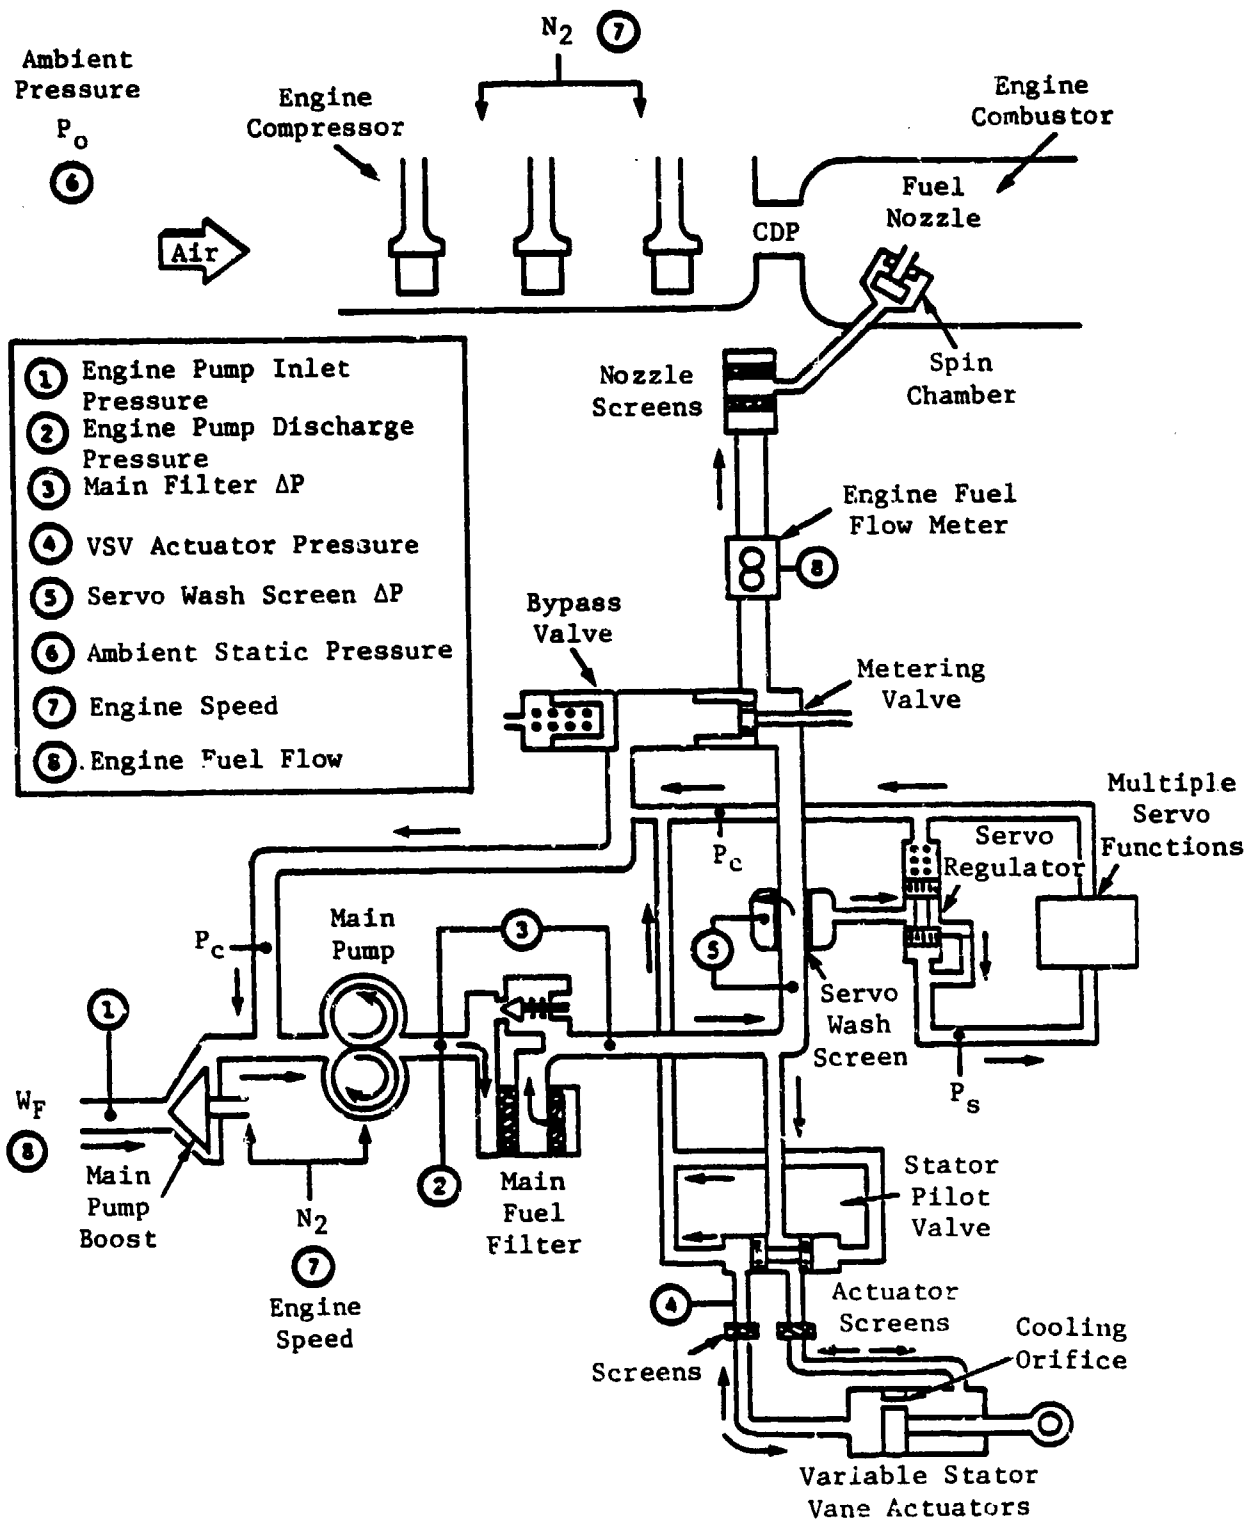
FIGURE 69. ENGINE FUEL SYSTEM SCHEMATIC

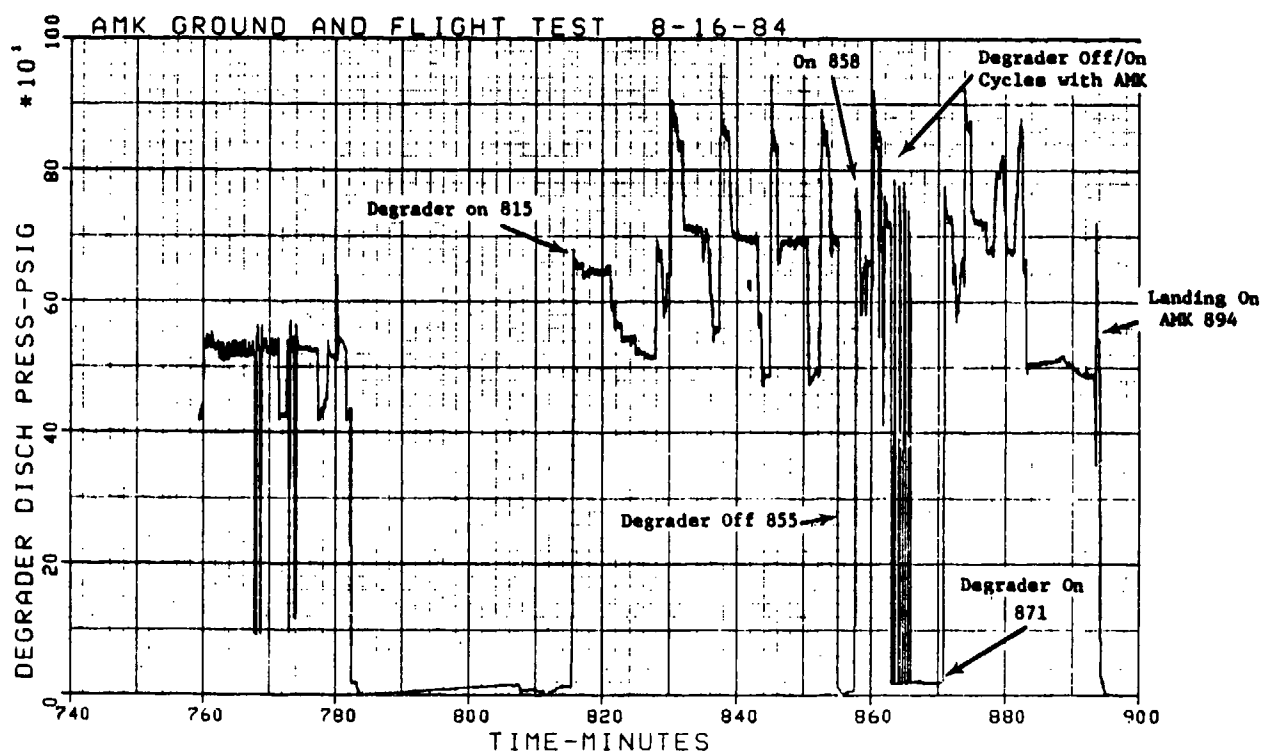
FIGURE 94. DEGRADER FUEL DISCHARGE PRESSURE

Figures 92 and 93 show No. 3 engine speed and EGT; degrader discharge pressure (Figure 94) provides a clear indication of degrader operation. The degrader was shut off 10 times. The first shutdown was for 2 minutes, and the last shutdown was for 5 minutes. During this period of degrader on/off cycling (time 855 to 871), the engine and aircraft were operated without constraint, including a 100-ft above-ground-level (AGL) go-around with the degrader off at

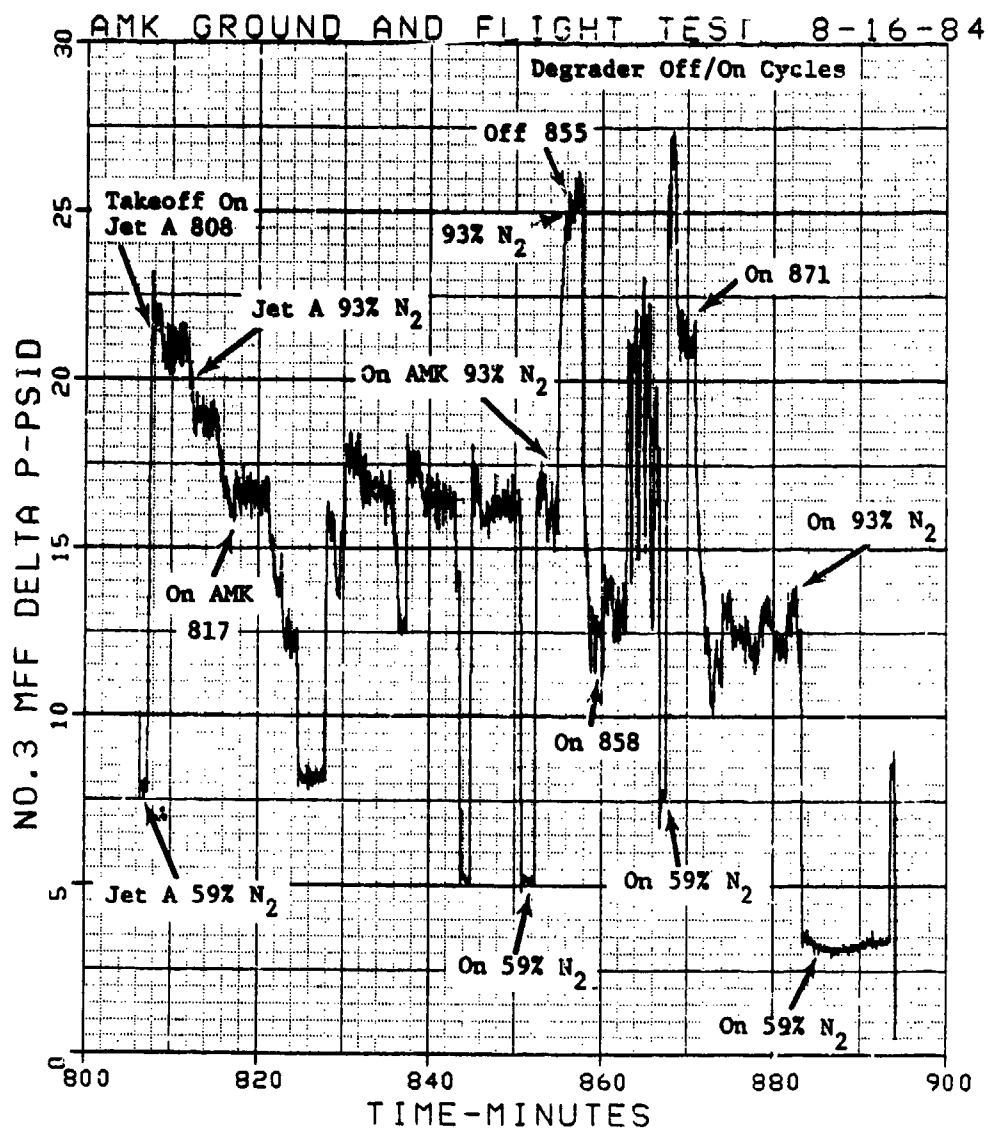
FIGURE 98. NUMBER 3 ENGINE MAIN FUEL FILTER  $\Delta P$

The main fuel filter responded readily to degrader operation, as can be seen in Figure 98. First, however, note the general decrease in  $\Delta P$  for operation of the No. 3 engine and degrader on AMK compared to Jet A. Pressure drop was about 50 percent less on AMK for either 59 percent or 93 percent engine speed. This supports the contention that degraded AMK has less filter-flow resistance than Jet A. Next, note what happened when the degrader was shut off. Filter  $\Delta P$ , with undegraded AMK, increased immediately to about 150 percent of degraded AMK value.

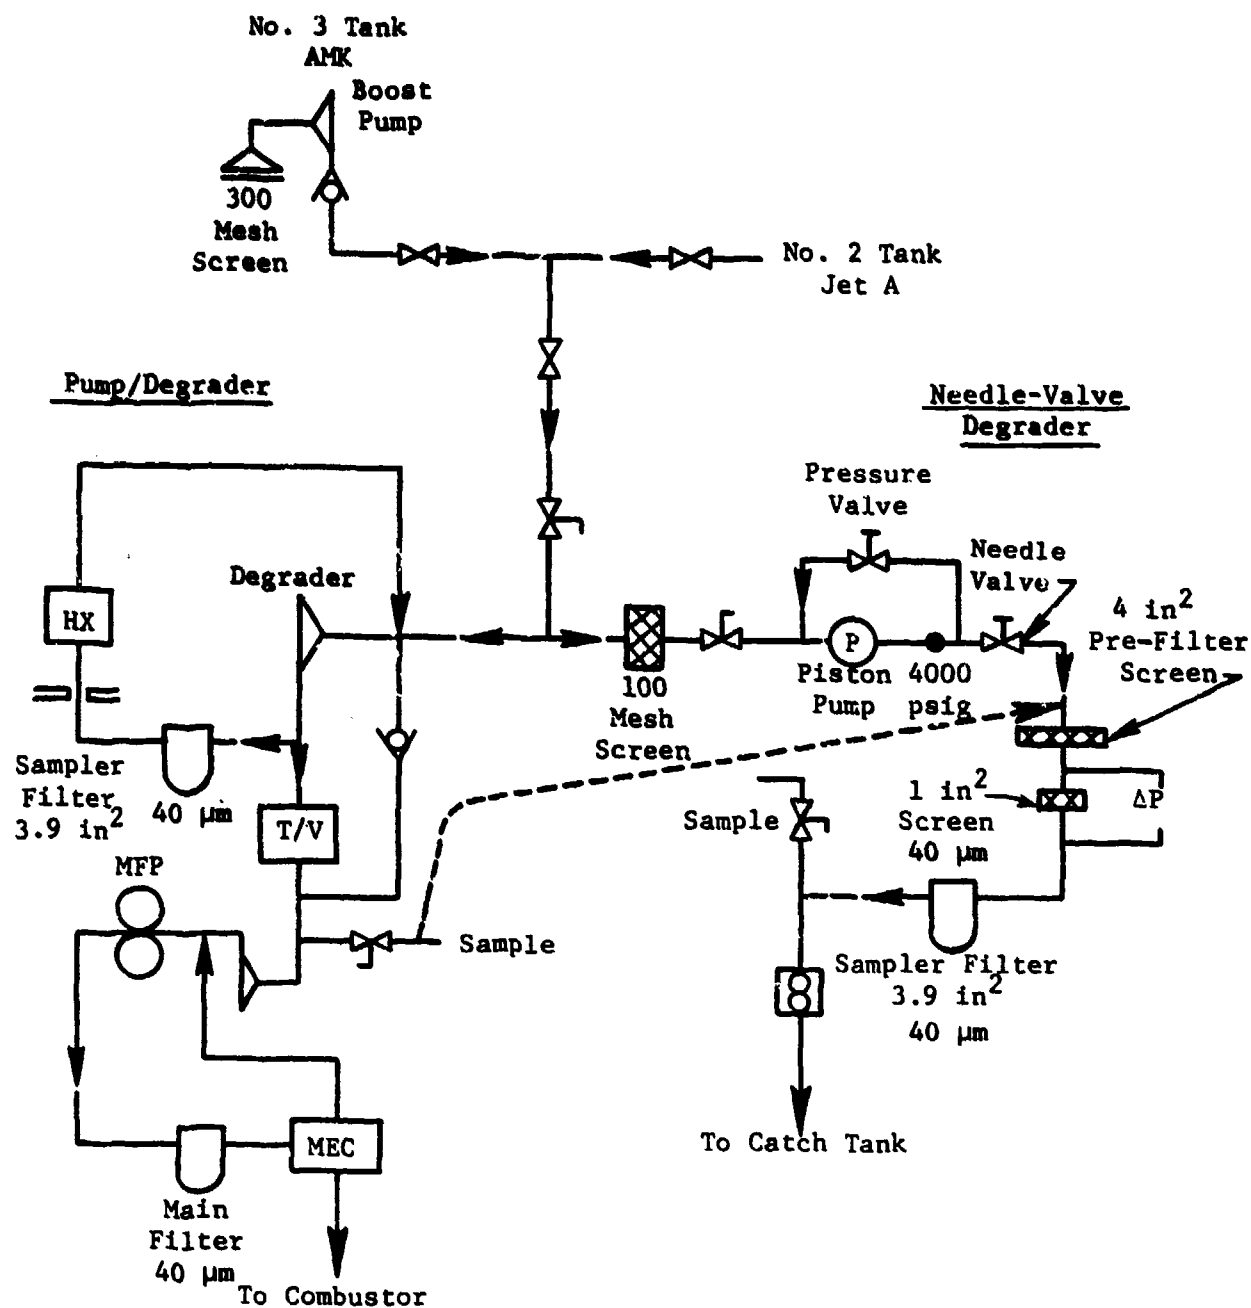
FIGURE 99. TEST SETUP FOR COMPARISON OF DEGRADERS

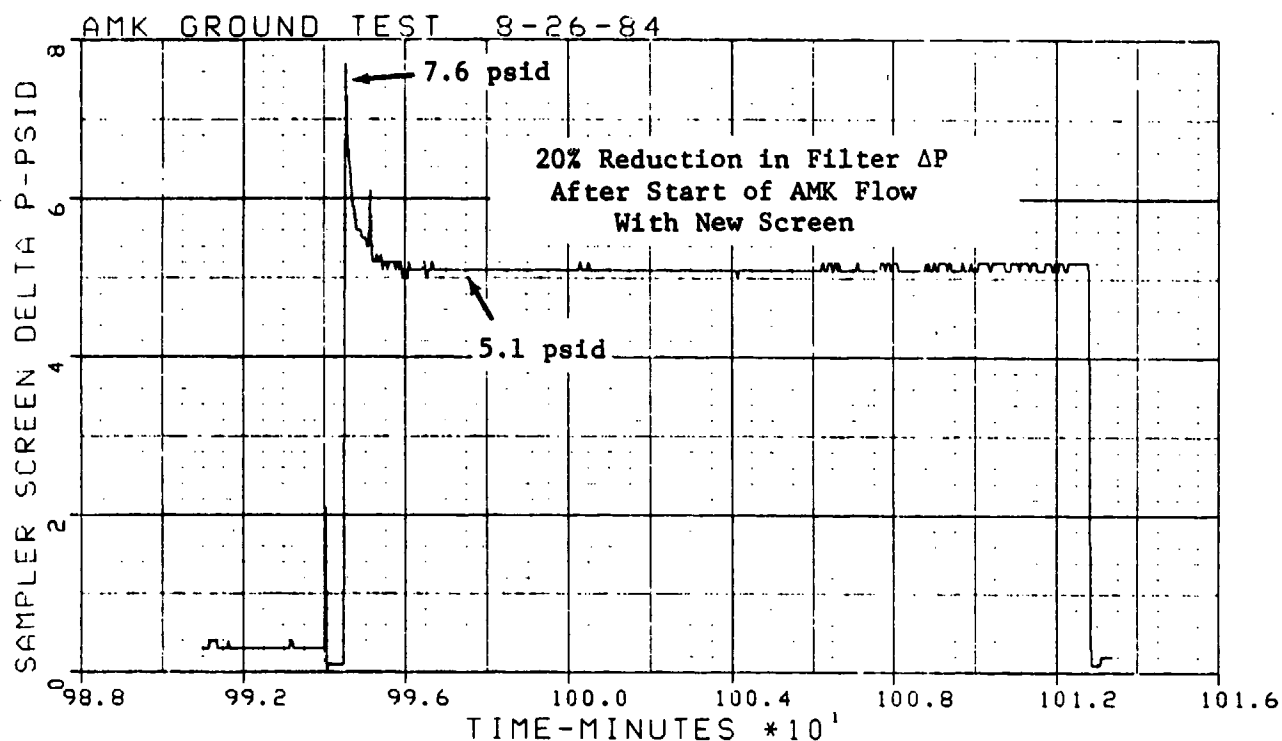
FIGURE 106. SAMPLER FILTER  $\Delta P$

Test results for freshly blended AMK, shown in Figures 104 through 106, were excellent. In Figure 106, note that sampler filter  $\Delta P$  decreased at near-constant fuel flow at the beginning of the test. This result was with a new sampler screen, not previously exposed to fuel of any type. Thus, this 20% reduction in filter  $\Delta P$  with AMK could not be the result of "washing" residual FM9 from the filter.

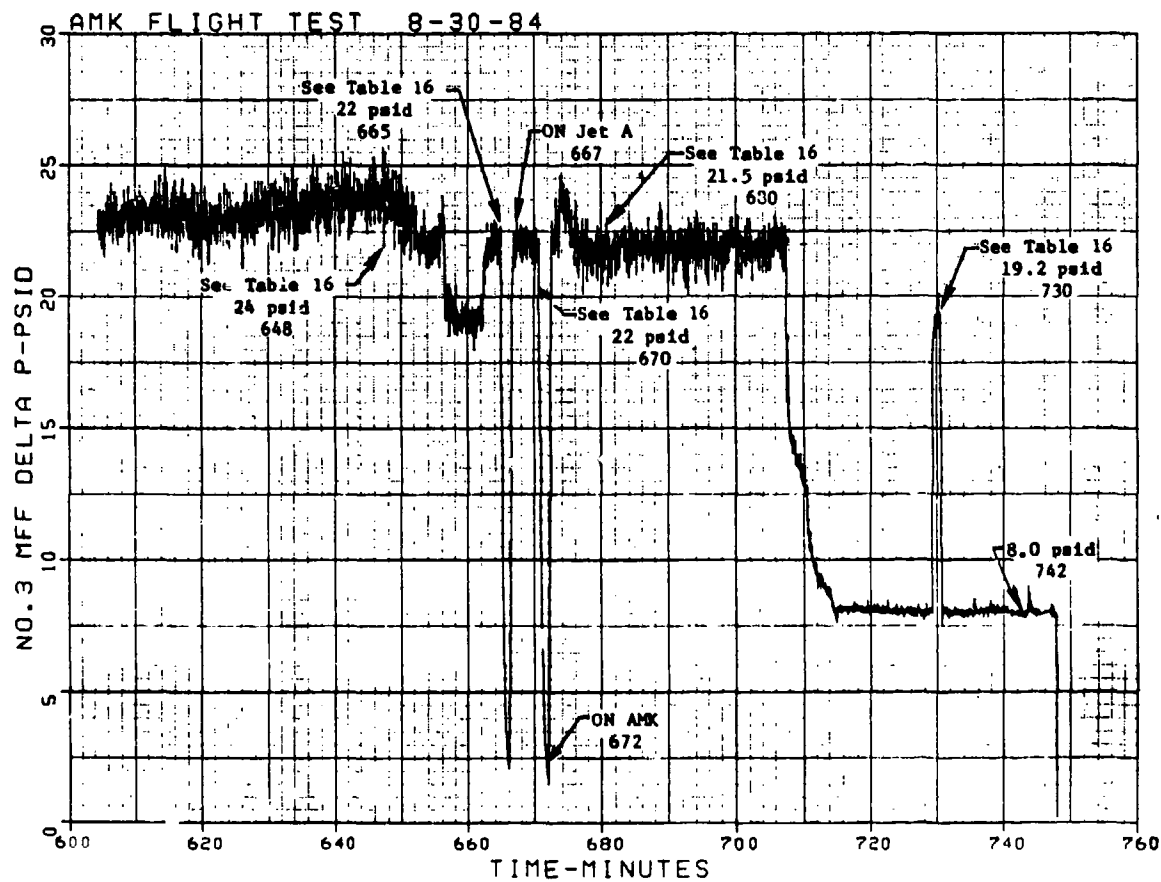
FIGURE 113. NUMBER 3 ENGINE MAIN FUEL FILTER  $\Delta P$

Figures 113 and 114 show periods of more or less continuous operation on AMK where there appeared to be a trend toward increasing filter pressure drop.

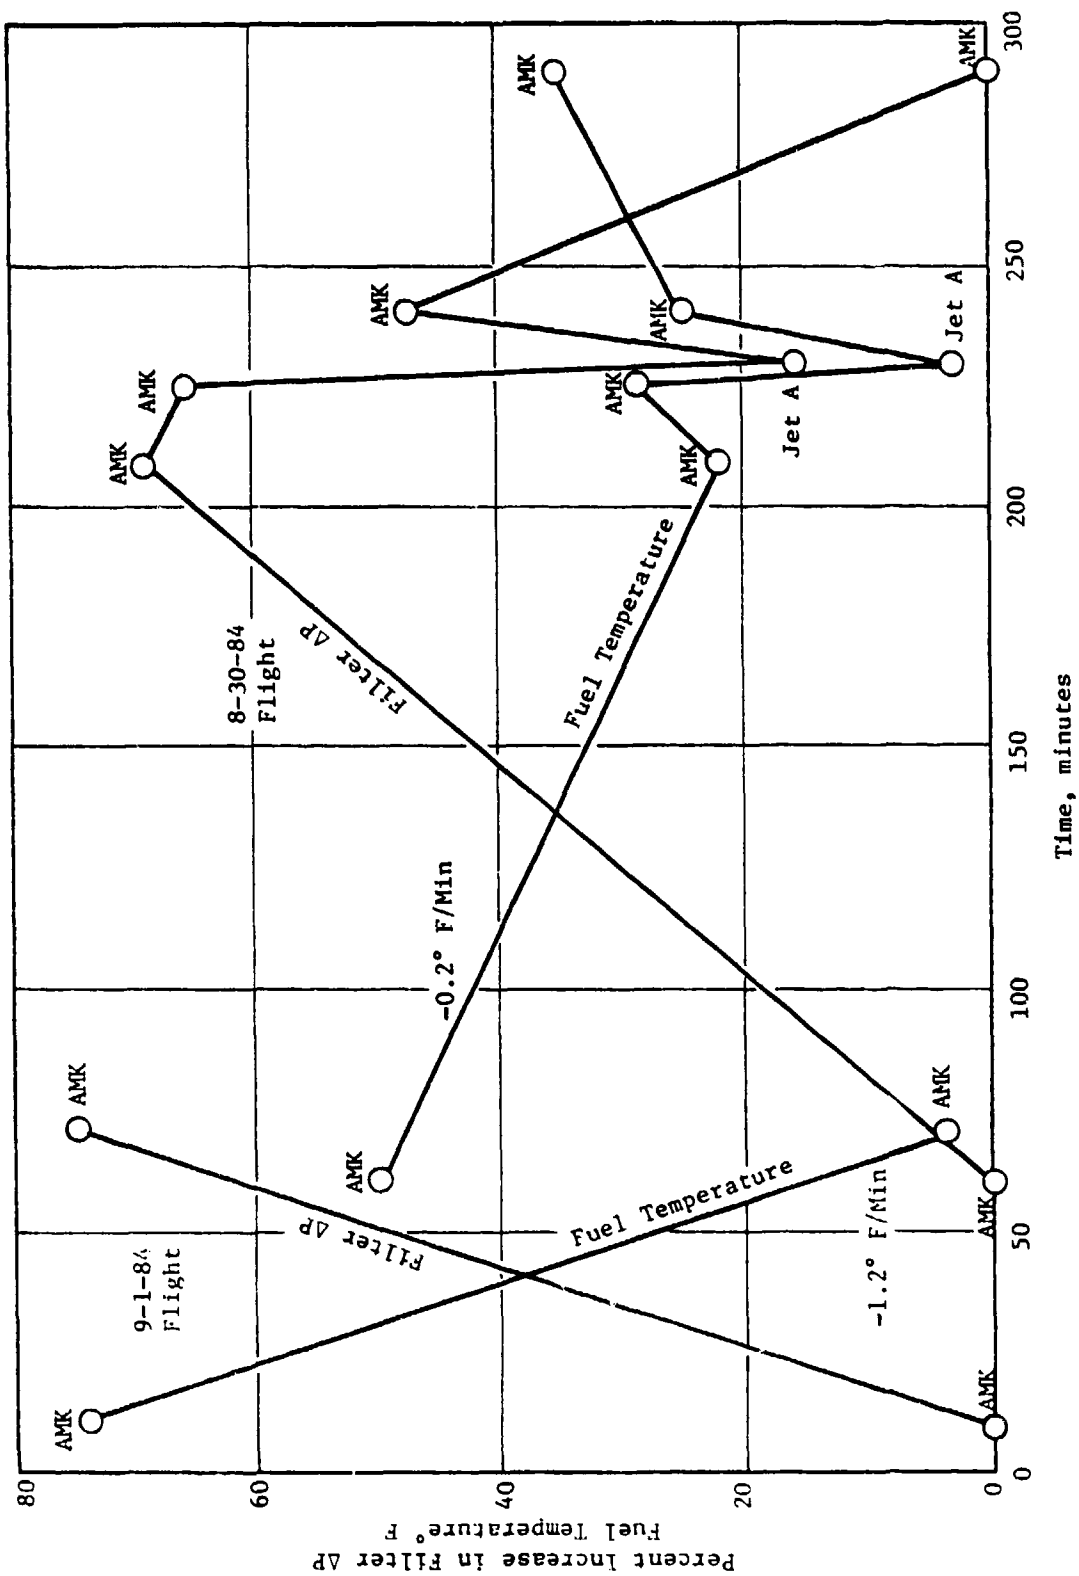
FIGURE 117. TREND OF SAMPLER FILTER  $\Delta P$  AS A FUNCTION OF DEGRADER FUEL INLET TEMPERATURE

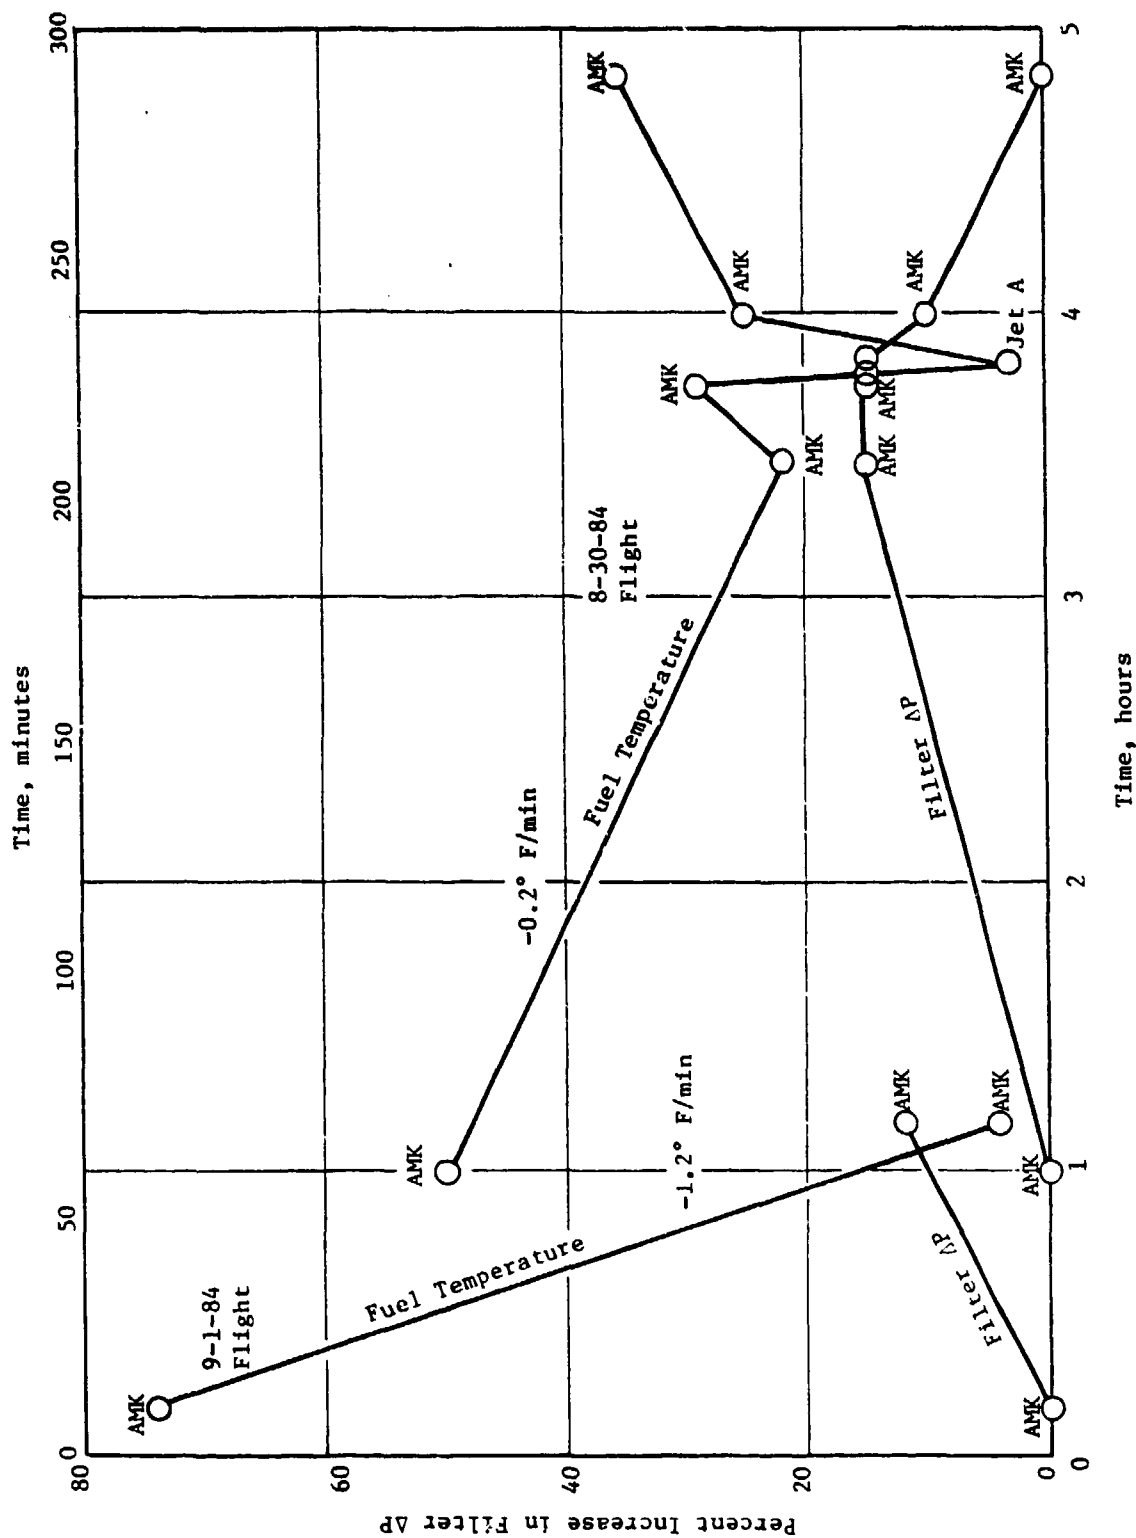
FIGURE 118. TREND OF MAIN FILTER  $\Delta P$  AS A FUNCTION OF DEGRADER FUEL INLET TEMPERATURE
